# Exam Problem by Dr. Judy Wood: Space Shuttle Columbia Disaster

## Introduction: EM 304 Test Problem 1

This is a problem for Mechanics of Engineering course EM 304 that Dr. Judy Wood, author of the famous book [Where Did The Towers Go](#), gave to her class in Clemson University on February 6, 2003.

## Problem 1 of EM 304 – Test #1 – February 6, 2003

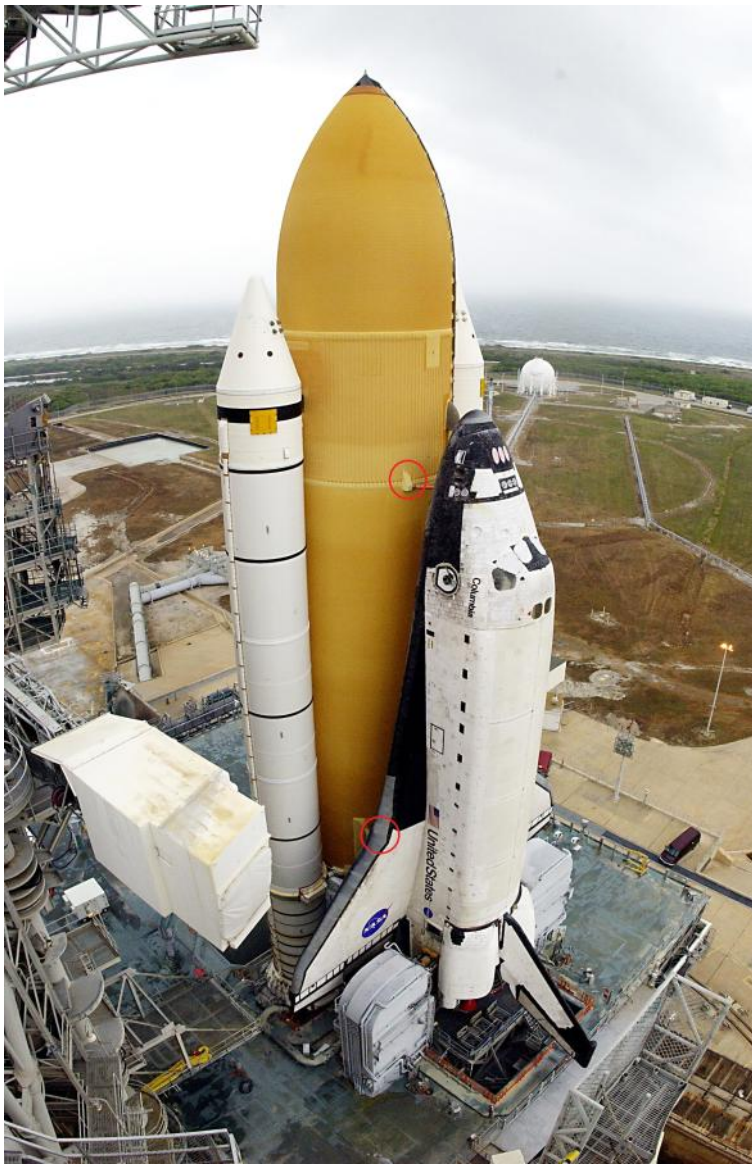
**Figure:** *Columbia* prior to launch. The circled area on the [external tank](#) (ET) is the left bipod foam ramp, and the circled area on the orbiter is the location that was damaged.

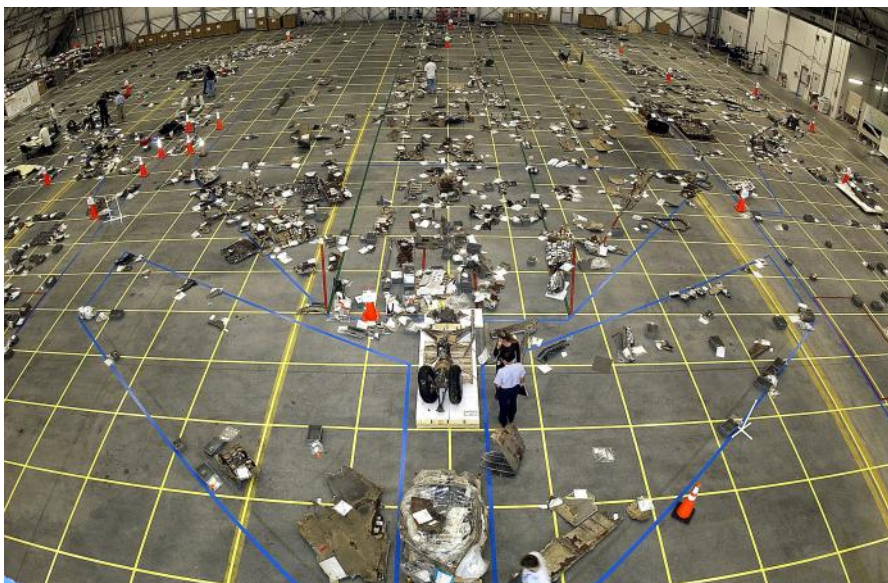
84,000+ parts recovered: A grid on the floor is used to organize recovered debris.

The search for *Columbia* debris ended in May.<sup>[17]:203</sup> Approximately 83,900 pieces of debris were recovered, weighing 84,900 pounds (38,500 kg), which was about **38 percent of the orbiter's overall weight**.

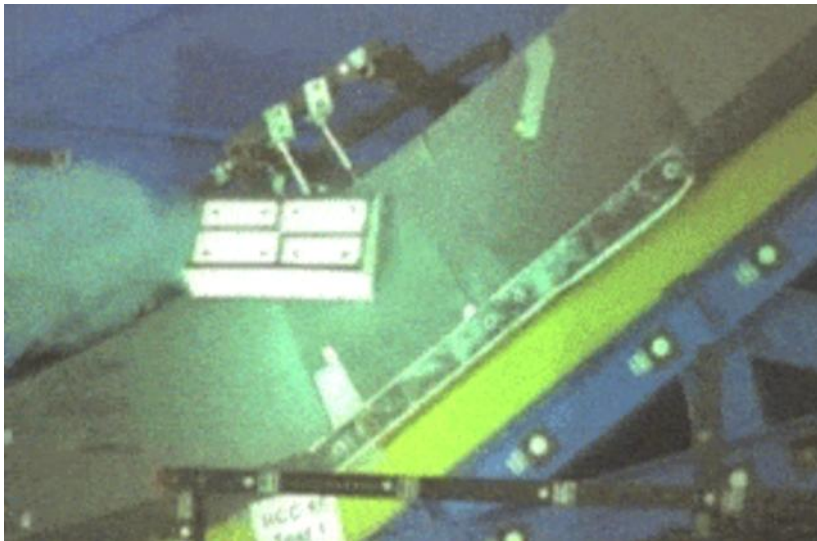
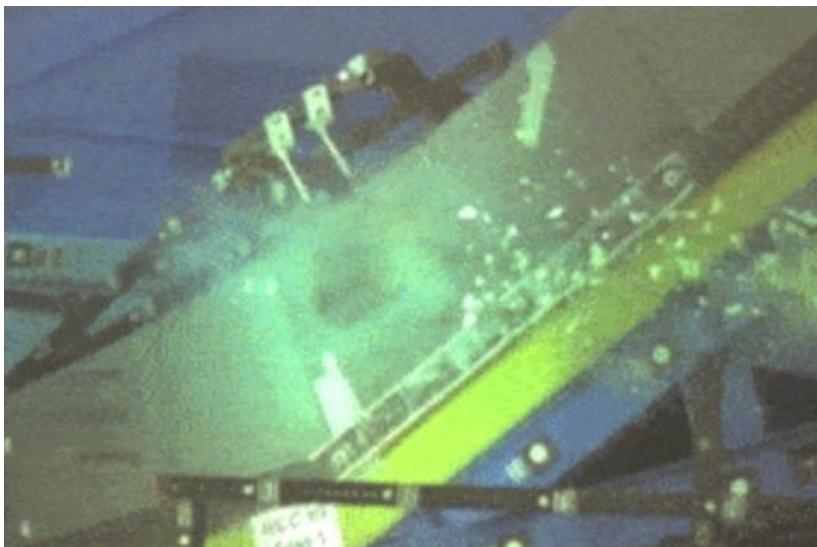
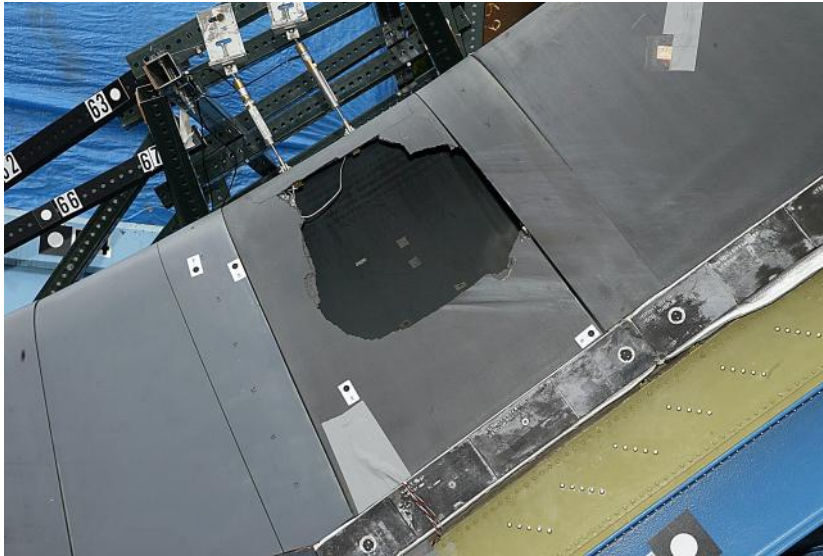
8. Close up of carbon-reinforced panel that was damaged by foam in test
9. Wide shot of hole, zoom in to close up

Here is a video of the foam strike test too: <https://youtu.be/ySiyzJEi01M>
